KAFFELOGIC
TOP CLOSURE
REPLACEMENT GUIDE

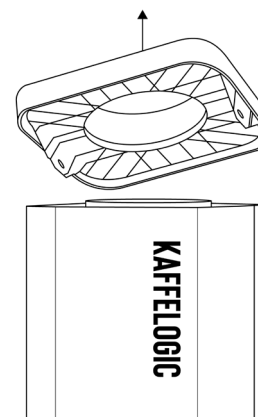
3

Carefully lift off the top closure making sure not to move the roast chamber.

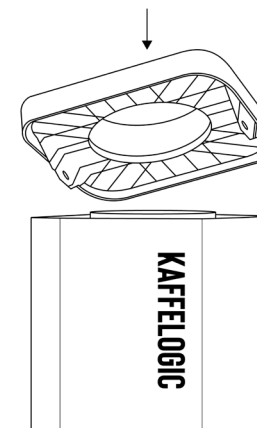
4

Place the new closure into your unit carefully. Line up the screw holes on the closure with the ones on the panels.
